Docket No. 217 – Development and Management Plan Inspection

Northeast Utilities Service Company Certificate of Environmental Compatibility and Public Need for the construction of a 345-kV electric transmission line and reconstruction of an existing 115-kV electric transmission line between Connecticut Light and Power Company's Plumtree Substation in Bethel, through the towns of Redding, Weston, and Wilton, and to the Norwalk Substation in Norwalk, Connecticut.

Date: August 5, 2004

Location: Norwalk Substation Expansion

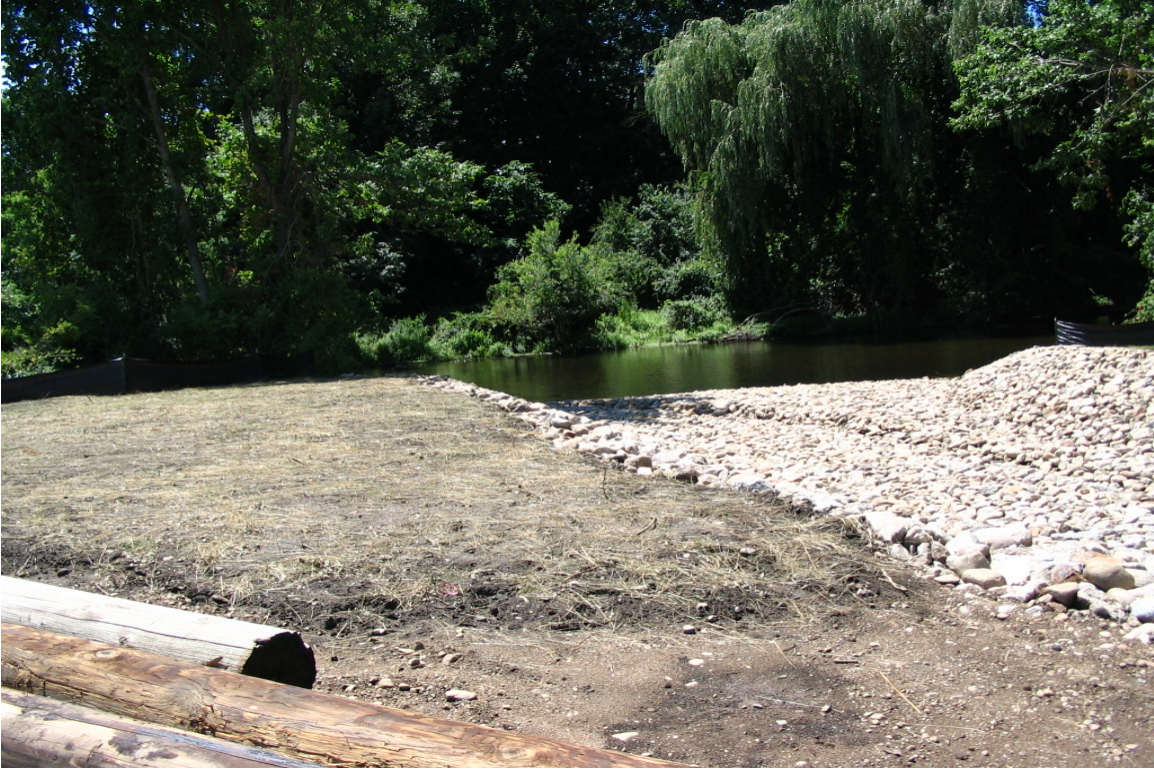
- Some areas along the channel which were recently seeded and mulched, were not showing much success in revegetation. 8/05/04	-Although the areas were fairly recently seeded. Some additional seed should be placed as the large geese population in the area may have removed it. 8/05/04
	-Some grass seed was recently placed on the small bare spot in the vegetation below wall #5. Some mulch and watering may be necessary to get growth to occur. 7/15-8/05/04	-Continue to monitor for sufficient vegetative growth and future stabilization. This spot could lead to a gully under the right conditions as it is in a fairly steep grade. 7/15-8/05/04
Inland Wetland and Watercourse encroachment and mitigation	<p>- The silt fence is still well in place along the river. 8/05/04</p> <p>- The areas along the channel are well under control with soil and straw mulch on the disturbed areas but additional seed may be necessary for grass cover. 8/05/04</p>	<p>- Continue to monitor silt fence and repair as necessary, especially in portions closest to the river.</p> <p>- There were no signs of sedimentation or erosion at either end of the channel. 8/05/04</p>

View of the connection to the Norwalk river at the southern end of the overflow channel. The recently seeded and mulched soil has not experienced much growth. Additional seed may be needed. 8/05/04

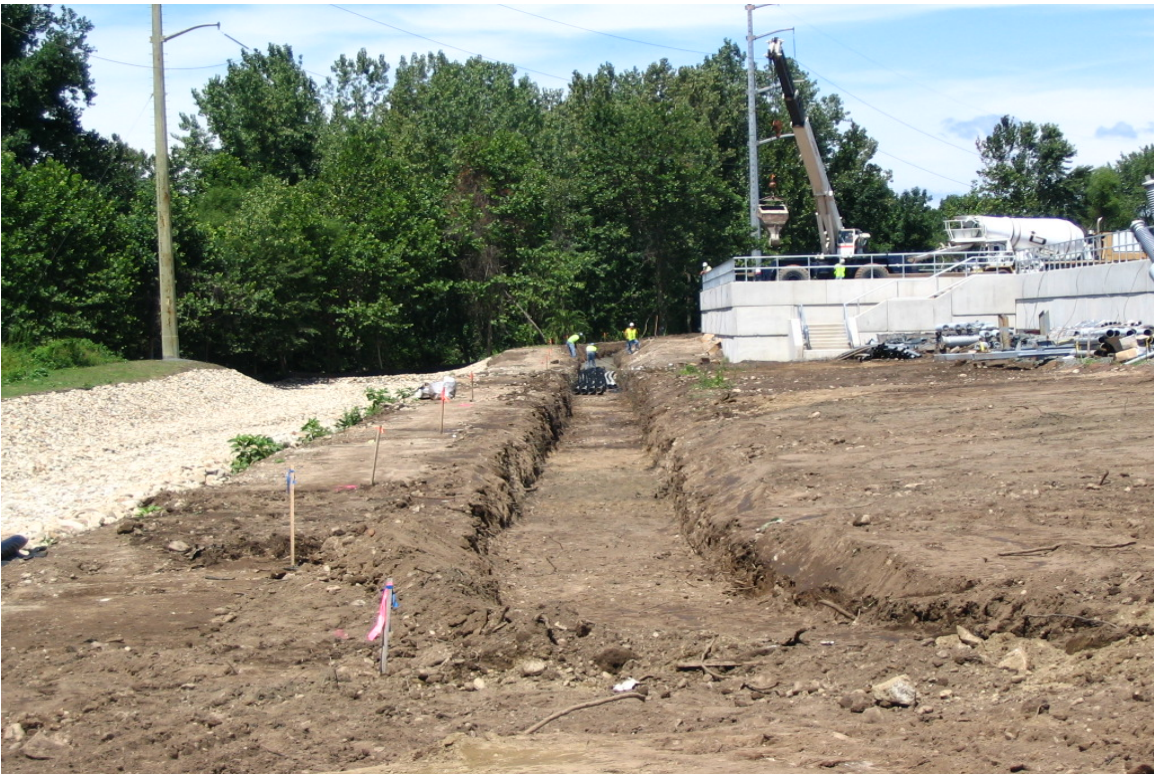
View of the excavation for the conduit installation, resuming from the northern portion of the site. The trench is well contained at this time. 8/05/04

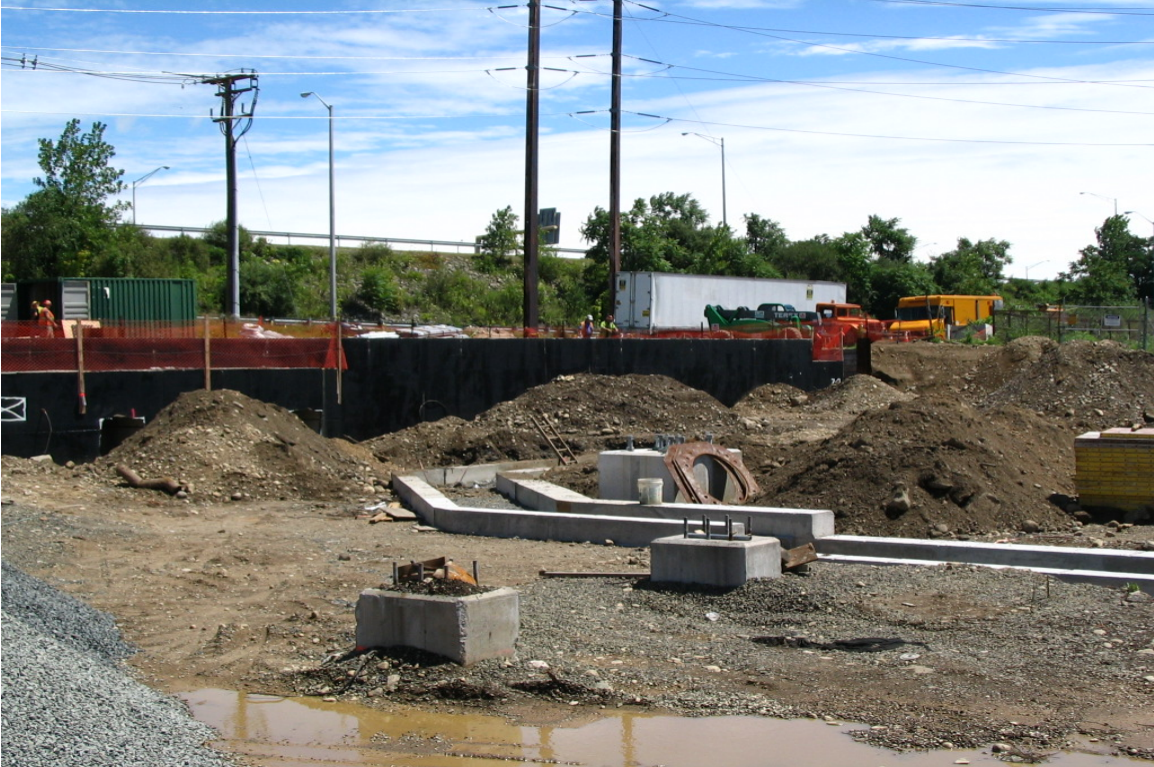
View of excavation and footings for the construction of retaining wall #3. The excavate is contained at this time. 8/05/04

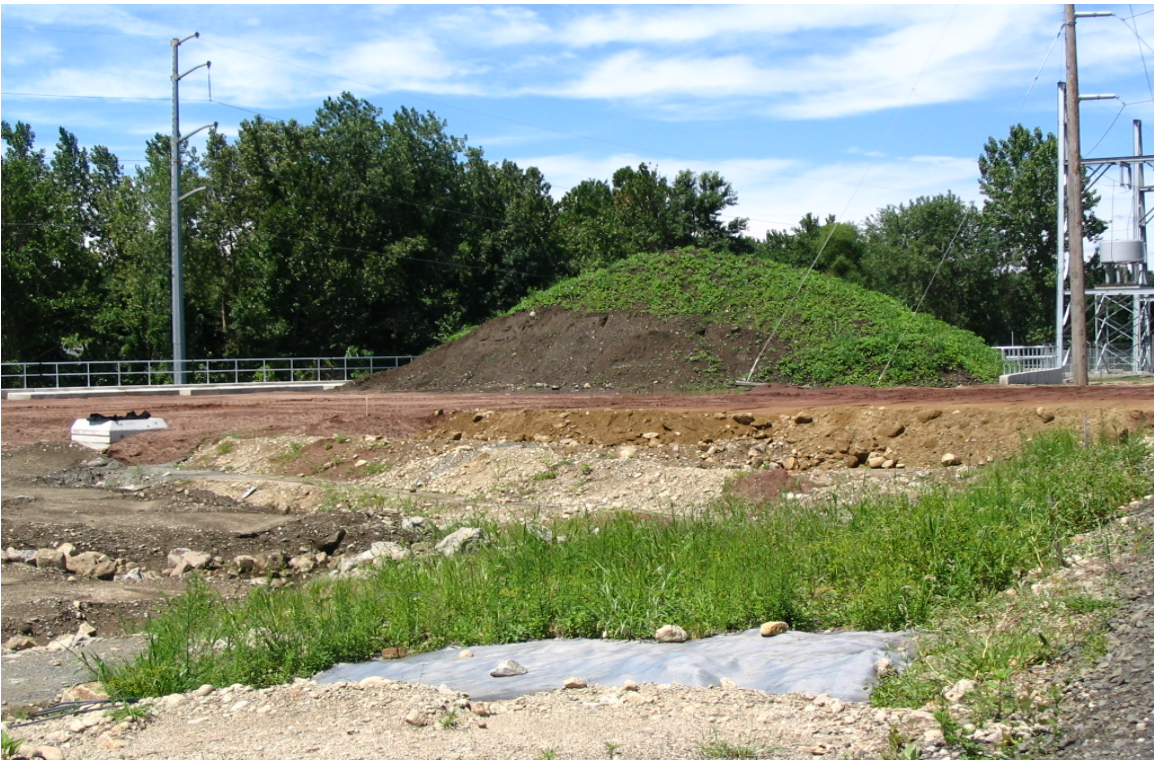
- The topsoil stockpile remains well contained along the retaining wall and fill activities to the east of wall #2 are largely complete. 8/5/04	- The pile will continue to be used where necessary in areas to be grassed in the future and all soil is well contained. 6/30-8/5/04

View of the topsoil stockpile and edge of the fill operations. 8/05/04

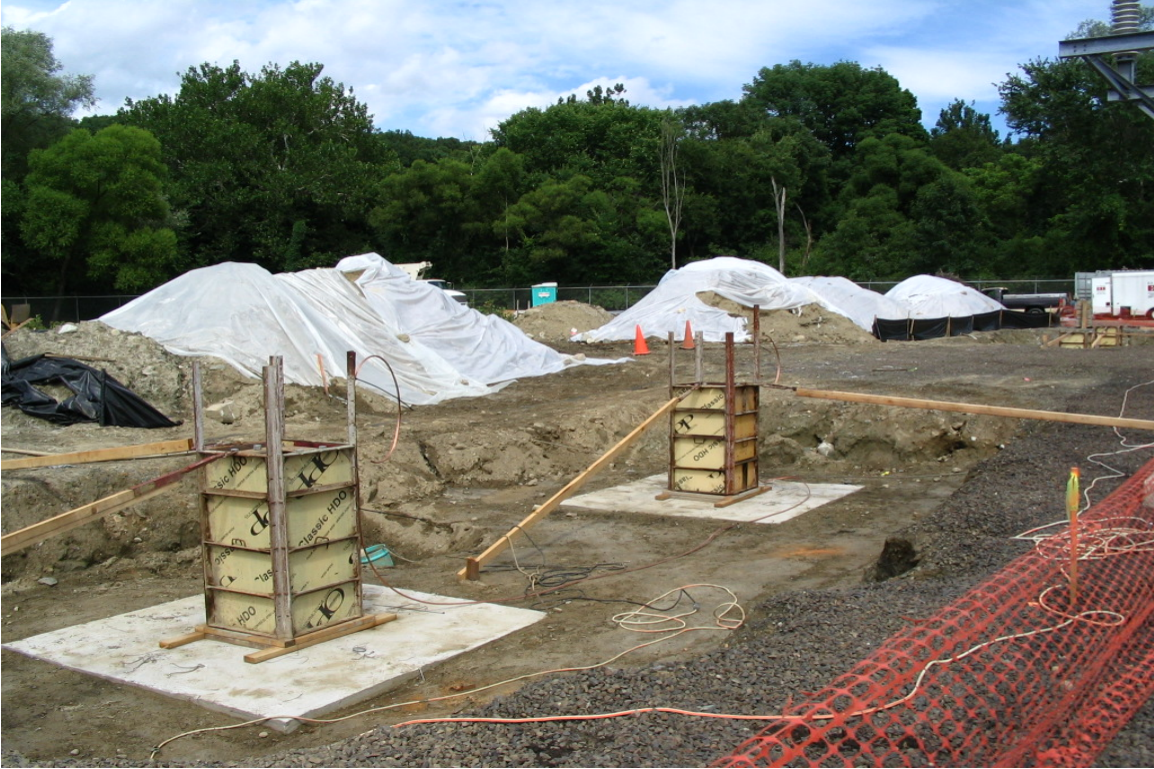
Areas of Inspection	Observation	Recommended Action
	- The existing small stockpiles have been sufficiently covered with plastic and are located well away from any sensitive areas. The rains did not cause any erosion to the stockpiles themselves. 7/28-8/05/04

View of the recently poured footings at Plumtree. Dewatering is still ongoing to keep the construction area dry. The stockpiles have been protected from erosion and sedimentation by the plastic sheeting. 8/05/04

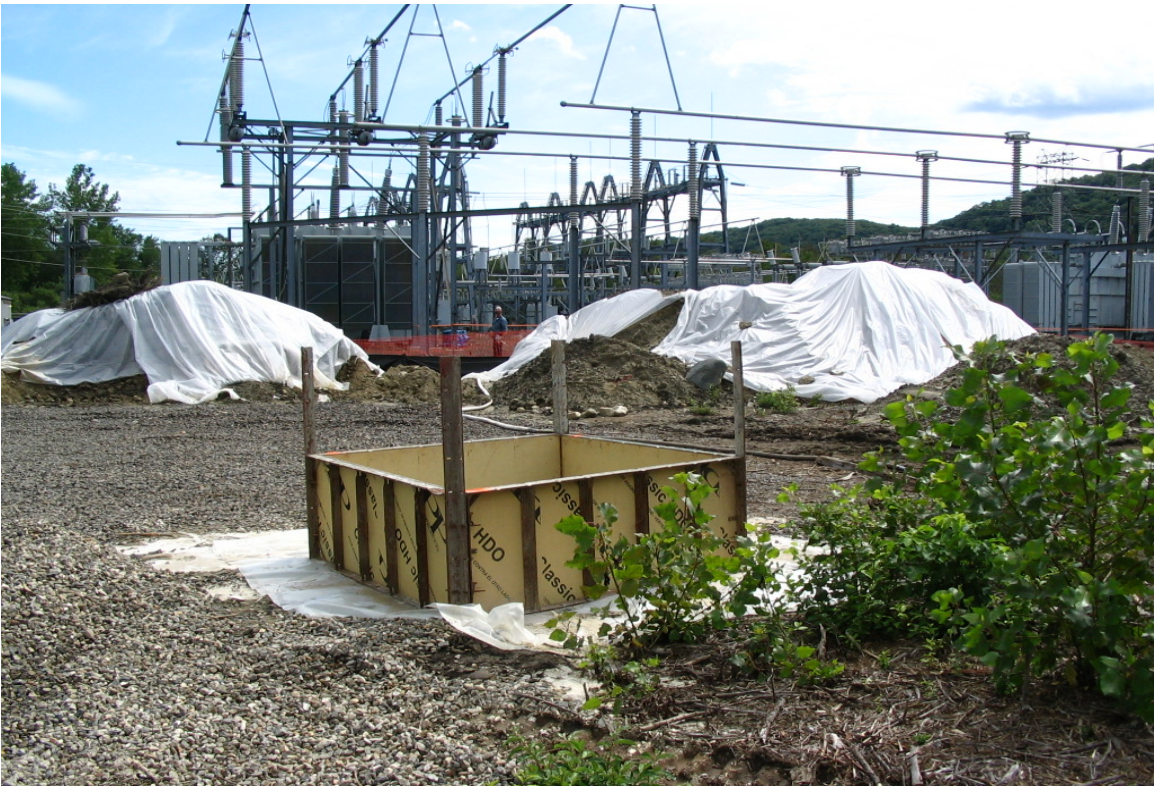
- A new, well built concrete washout station has been constructed and is being used appropriately. 8/05/04	- The main objective is to keep all washout water from resource areas and storm drains.
Inland Wetland and Watercourse encroachment and mitigation	- Wetlands are located around the outskirts of the substation yard but no work is in their vicinity at this time. 8/05/04	- None at this time.
State species of concern, threatened and endangered species	- No species of concern are located in this area of construction.	- N/A
Vegetative clearing limits (including trees to save or danger trees noted)	- No vegetation outside of the substation yard will need to be cleared during the expansion work.	- N/A
Dewatering	- Dewatering activities continue in order to remove standing water from the excavations for footing installation. 7/28-8/05/04 - The water is being directed to a flat area within the yard and is not reaching any wetland areas at this time. 7/28-8/05/04	- Both areas of dewatering have not had any issues with nearing the wetlands. If the volume of water increases, the flow should be filtered through a bag or haybales to reduce the chance of reaching off site. 7/28-8/05/04

View of the well constructed concrete washout station which is being used appropriately. 8/05/04
